Manhole Inspection Summary

Manhole # S17GG2013MH

Insp Date: **10/4/06 1:01 PM**

Location Address: **5801 SMITH AVE**

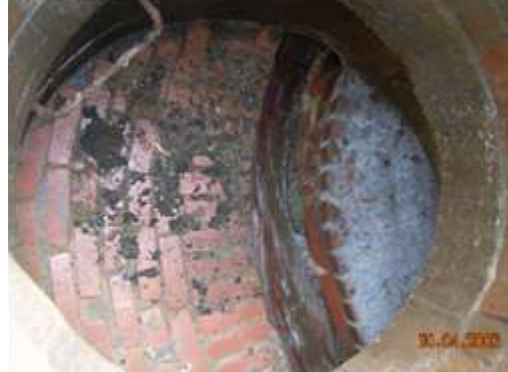
Top View

Bench ☒ Exists Material: **Brick** ☐ Parged ☒ **Debris** (not Condition related)

Steps Count: **1** Missing: **0** ☒ **Corroded**

Surcharge ☒ **Evidence Of Surcharge** Depth: **1** (ft.) ☐ Active Surcharge Present

Corroded step. Evidence of surcharge - Bench debris.

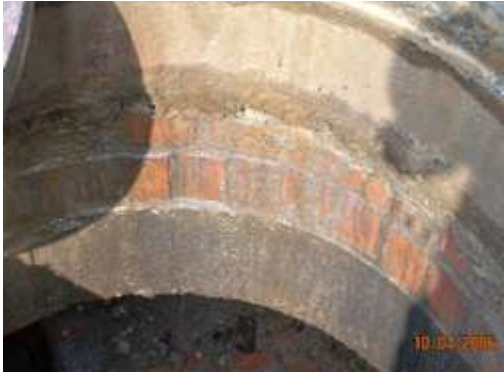
Defect

Frame Offset: **0** (in.) Condition: ☐ Sound ☐ Cracked ☒ **Leaks**

Condition: ☐ Sound ☐ Cracked ☐ Root Intrusion ☐ Loose Brick ☒ **Deteriorated**

Infiltration: ☐ None ☒ **Joint** ☐ Cracks ☒ **Mortar** ☐ Roots ☐ Wall

Frame leaks. Adjustment infiltration.

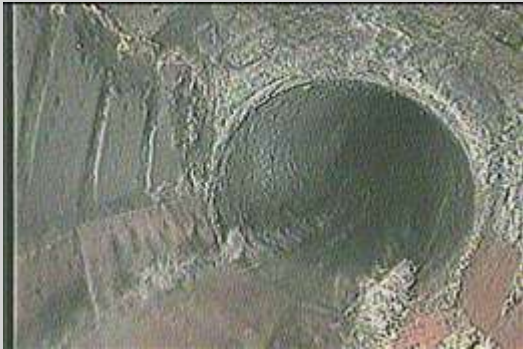
8 in. Circular Gravity Sewer Pipe Out @ 12 O'Clock

Deposits: ☐ None ☐ Mud ☐ Sludge ☐ Debris ☒ Grease

Silt Depth: **0** (in.) Deposits Extent: **Light**

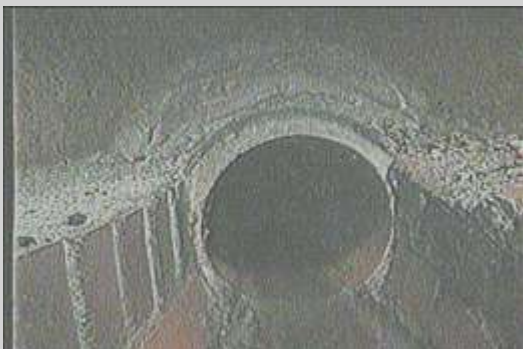
8 in. Circular Gravity Sewer Pipe In @ 5 O'Clock

Infiltration: **Evidence** Pipe Seal Cond: **Unknown**
